Old Clarkesville Cemetery Masterplan, Survey and Headstone Identification & Restoration Guide

City of Clarkesville

Amec Foster Wheeler Environment & Infrastructure, Inc.

May 2018

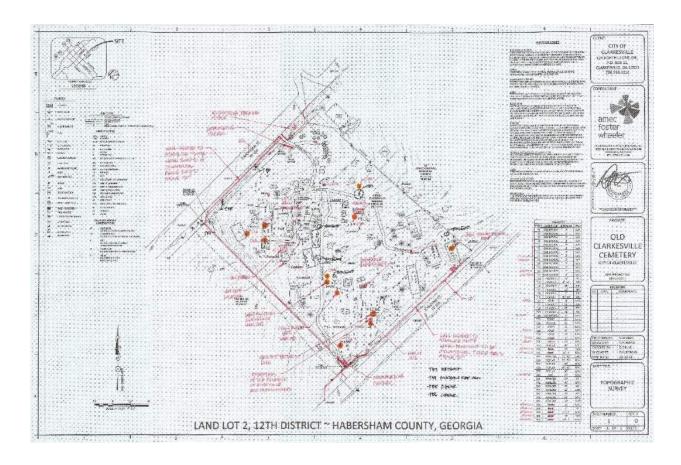
Field Map used by the master planning team to document trees and other unique features of the Cemetery.
